# ACCELERATOR MODULE REPAIR FOR THE EUROPEAN XFEL INSTALLATION

E. Vogel, S. Barbanotti, F. Hoffmann, K. Jensch, D. Kostin, L. Lilje, W.-D. Moeller, M. Schmoekel, H. Weise, DESY, Hamburg, Germany  
S. Berry, O. Napoly, CEA, Irfu, DACM, Centre de Saclay, France  
M. Sienkiewicz, J. Swierblewski, M. Wiencek, IFJ PAN, Krakow, Poland

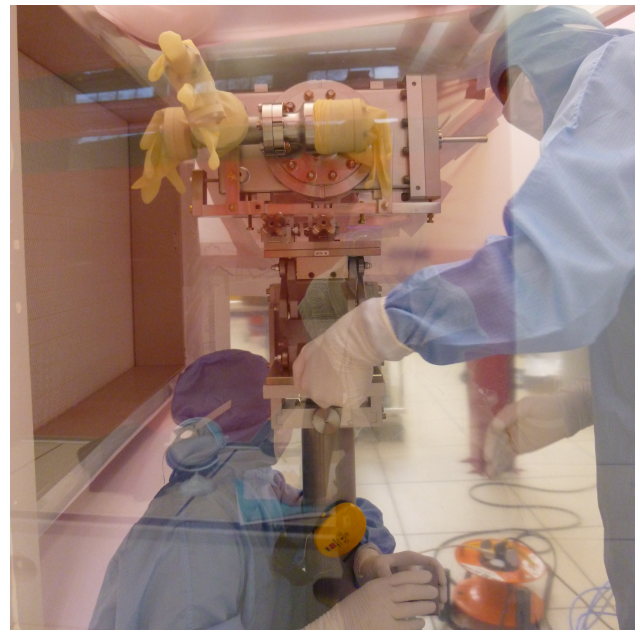
After the incoming inspection and the survey check have been performed at the AMTF, the upstream gate valve of XM54 was found defective. Normally the module required a disassembly and the complete string entering a clean room. This was incompatible with the module production running at full speed due to the blocking of workstations and personnel needed elsewhere. For almost one year XM54 was put aside and solutions were evaluated. Then the module was brought to CEA and disassembled with the string still hanging under the cold mass in front of the clean room. The support used for the gate valve assembly inside the clean room was moved on the rail system outside the clean room

Figure 3: Locan clean room with horizontal laminar flow used for the exchange of the defective gate valve of XM54.

and a local cleanroom with horizontal laminar flow installed around the upstream end of the module including the gate valve and the support (Fig. 3). The gate valve exchange was controlled by a particle counter. After re-assembly the module has been tested at the AMTF for the first time. The performance of the first cavity is degraded by field emission; all other cavities kept their performance above the (administrative) RF power limitation at 31 MV/m. The module provides an average usable gradient of 30.1 MV/m and is installed in the tunnel.

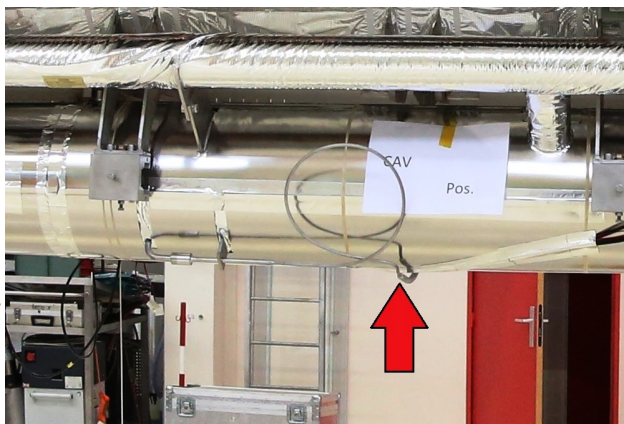
XM8 has been assembled at CEA in spring 2014, when the module assembly was still in the ramp up phase. Nevertheless, the 2 K circuit consisting of the 2-phase pipe itself, the warm-up cool-down line and the cavity tanks was never suspicious-looking for any leaks. Connecting the module to the AMTF test stand two leaks appeared. One in the bellows of the coupler 5 push rod and one at the 2 K circuit with a leak rate of  $8 \cdot 10^{-8} \frac{\text{mbar}\cdot\text{l}}{\text{s}}$ . In situ exchange of the coupler push rod bellows cured the coupler leak. Separating the process lines to enclose the area where the leak is located revealed the leak location somewhere at 2-phase line and warm up pipe. In October 2014 the module was removed from the test stand without cold test, wrapped to guaranty low humidity and put aside for later investigation and repair as personnel was tight during the ramp up phase. In October 2015 the module has been brought to "Halle 3" for further investigations. Motivated by the experience with leaks at the magnet current leads of XM21 the magnet current leads were examined first without finding a leak in this area. Then XM8 was disassembled to make the 2 K circuit accessible. The leak was found at the capillary on the warm-up cool-down pipe connection at cavity 6 (Fig. 4). The weld was repaired and the following leak check at warm showed no anomalies. The repair took 38 days. In March 2016 the cold test resulted in an average usable gradient of 26.3 MV/m. After the warm up a  $10^{-9} \frac{\text{mbar}\cdot\text{l}}{\text{s}}$  leak has been found again in the 2 K area. The module was put aside for further investigation, presently still ongoing.

Figure 4: Position of the leak at the XM8 Helium filling line. The photograph shown here was taken at a different module at the CEA assembly line.

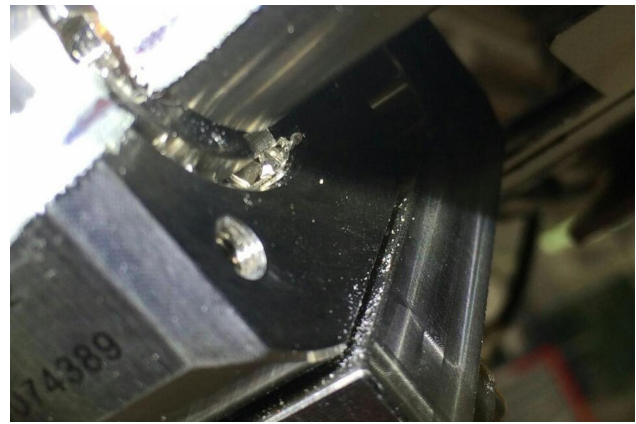
Different problems arose while testing the module XM93: two helium leaks appeared at the 2 K and 70 K area respec-

Figure 5: Multi-layer insulation trapped in the XM93 ball bearing of the tuner motor.

tively and cavity 1 could not reach its nominal frequency of 1.3 GHz nor go back to its nominal warm up position once the module was cold. All the problems were solved without disassembling the module; the leaks required some re-welding of the end pipe connections outside the module, while the frequency tuning problem needed some part exchange: the optical inspection performed after warm up revealed multi-layer insulation (from the test stand) trapped in the ball bearing of the tuner motor (Fig. 5). The drive unit was exchanged and the tuner performances measured to verify the results of the repair work. The frequency change operating the tuner motor was within the acceptance values.

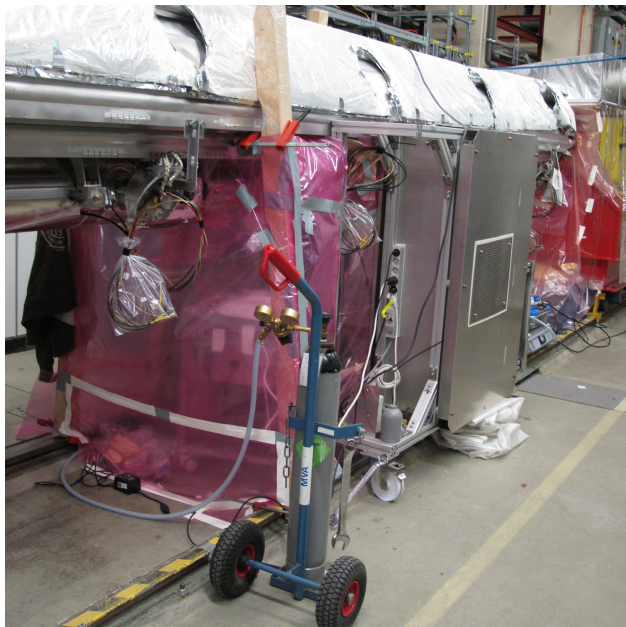
In January 2015 testing of module XM22 started. A leak found at the A-flange of coupler 2 was repaired in situ by exchanging the O-ring. Due to a leak venting the insulation vacuum caused by a loose fastening nut at a coaxial feed-through the testing had to be interrupted and the module warmed up. The flange with the leaky feed-through was exchanged. After the next cool down a heat load 10 times nominal has been found and the module warmed up for investigation. Finally, a  $10^{-9}$  to  $10^{-7} \frac{\text{mbar}\cdot\text{l}}{\text{s}}$  leak at the beam line appeared. Due to the time delay between the spraying of Helium and the detection inside the beam vacuum volume the leak was expected somewhere at an inner position. We removed the module from the test stand without being tested and stored it in the XFEL tunnel, which was still quite empty at this time. In January 2016 the module was brought back to the AMTF for warm coupler disassembly and subsequently to "Halle 3" for disassembly of the thermal shields permitting access to the string. In March 2016 the HOM #2 feed through of cavity 7 has been found leaky. We decided to try an exchange in a local clean room with the string of cavities still hanging at the cantilever (Fig. 6). To provide access

Figure 6: Local clean room at XM22 hanging at the cantilever for HOM antenna exchange.

to the feed through the tuner was uninstalled. The local clean room has been qualified with particle counters and the feed through exchanged. After reassembly XM22 has been fully tested for the first time in April 2016: All cavities kept their performance w.r.t. the vertical test providing an average gradient of 15.8 MV/m and the heat load measured was within the specification. The module has been installed.
